Manhole Inspection Summary

Manhole # S33M1_006MH

Location Address: **400 Swale Ave.**

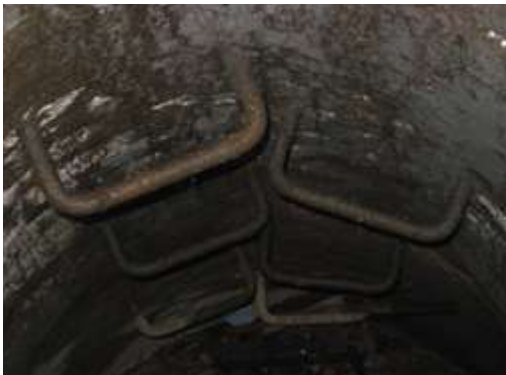
steps

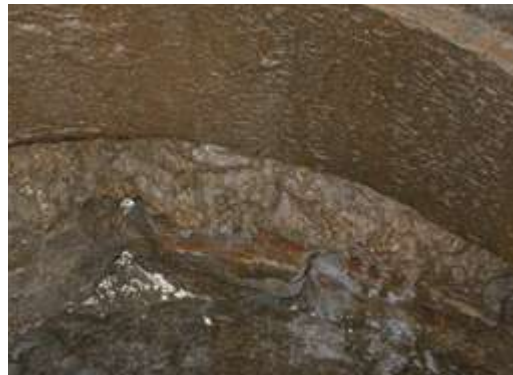
Defect 1

Condition: ☐ Sound ☐ Cracked ☐ Root Intrusion ☒ **Loose Brick** ☐ Deteriorated

Infiltration: ☐ None ☐ Joint ☐ Cracks ☒ **Mortar** ☐ Roots ☐ Wall

loose brick and mortar on chimney

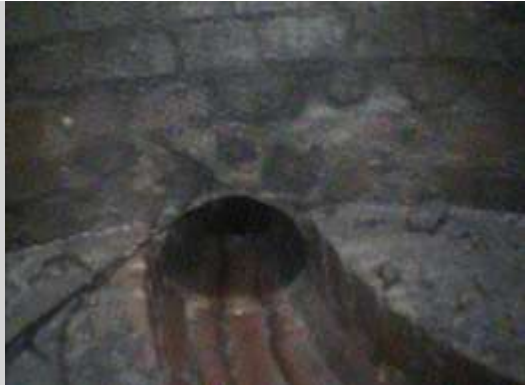
12 O'Clock Outflow

8 in. Circular Gravity Sewer
Pipe Out @ 12 O'Clock

Infiltration: **None** Pipe Seal Cond: **Sound**

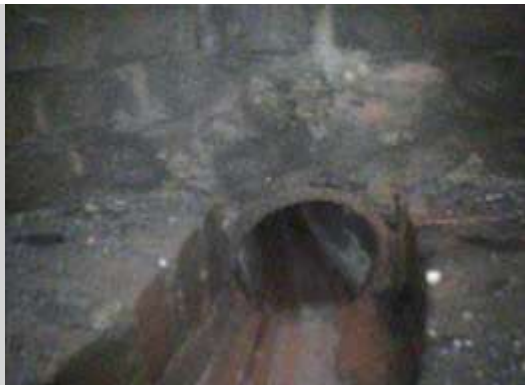
5 O'Clock Inflow

6 in. Circular Service Sewer
Pipe In @ 5 O'Clock

Infiltration: **None** Pipe Seal Cond: **Sound**
